USE OF AIRBORNE LASER SCANNING DATA FOR THE DETECTION OF CHANNEL DYNAMICS IN SLOVAKIA

Miloš Rusnák, Lukáš Michaleje

GEOGRAFICKÝ
ÚSTAV SAV

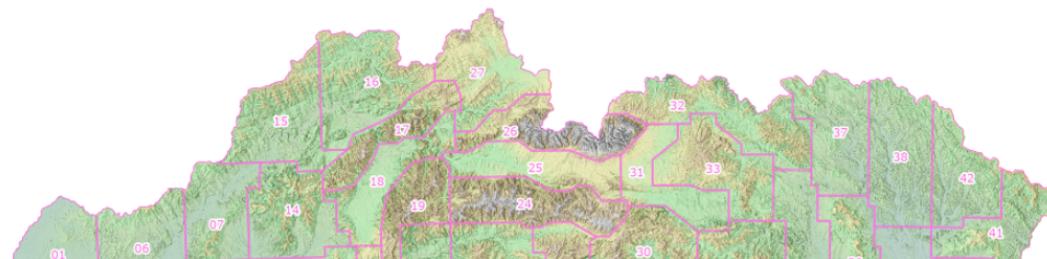
Since 2017, the Geodesy, Cartography and Cadastre Authority of the Slovak Republic (ÚGKK SR) was preparing (in a contractor manner) a new Digital Terrain Model (DTM 5.0) of the entire territory of the Slovak Republic created from Airborne laser scanning (ALS) data. In May 2023, the 1st cycle of the ALS project was completed by making the seamless DTM 5.0 of the entire territory of Slovakia available to the public.

In the 1st cycle of the project, the territory of Slovakia was divided into 42 sites (lots). The scanning was carried out in the vegetation-free winter period gradually from the west to the east of Slovakia.

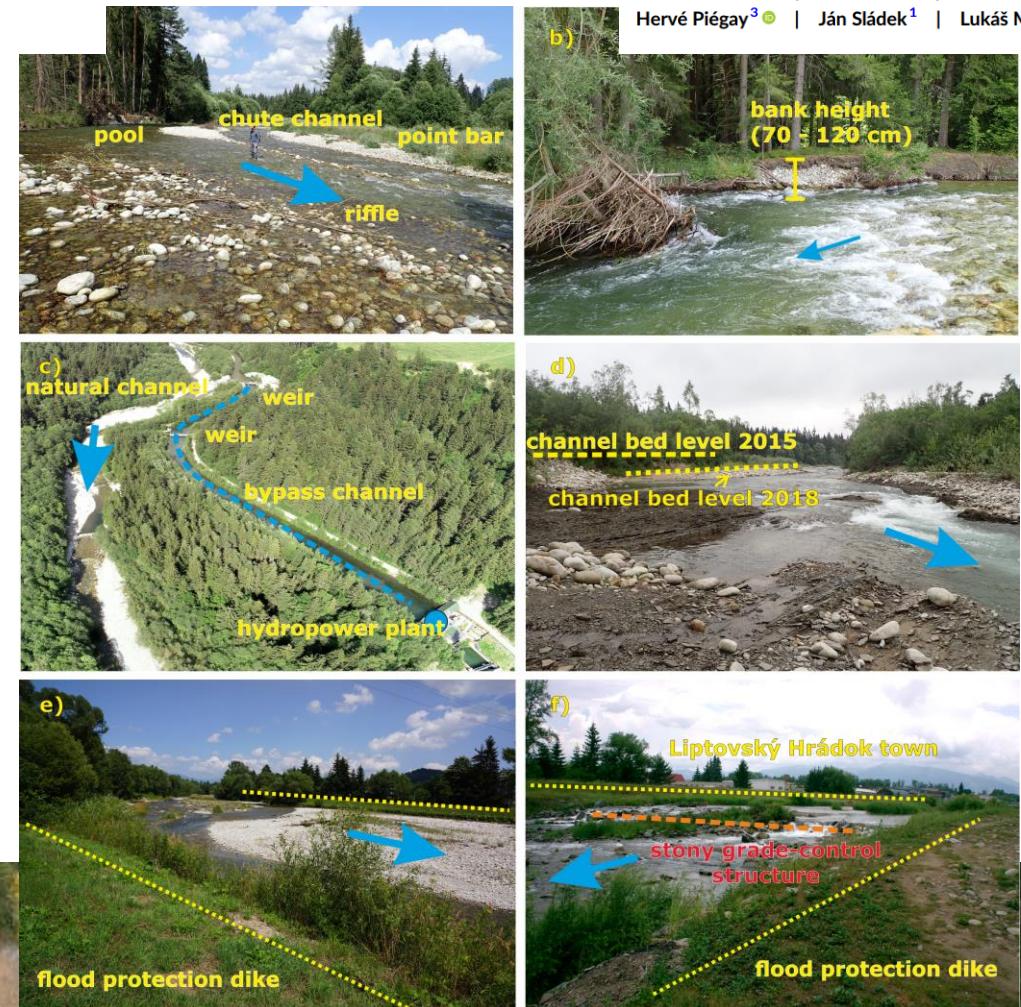
River incison

Inferring channel incision in gravel-bed rivers: Integrating LiDAR data, historical aerial photographs and drone-based SfM topo-bathymetry
